## Report A-052/2005

Accident involving a  
PZL M18A aircraft,  
registration EC-GAB,  
on 4 September 2005,  
in Requena (Valencia)

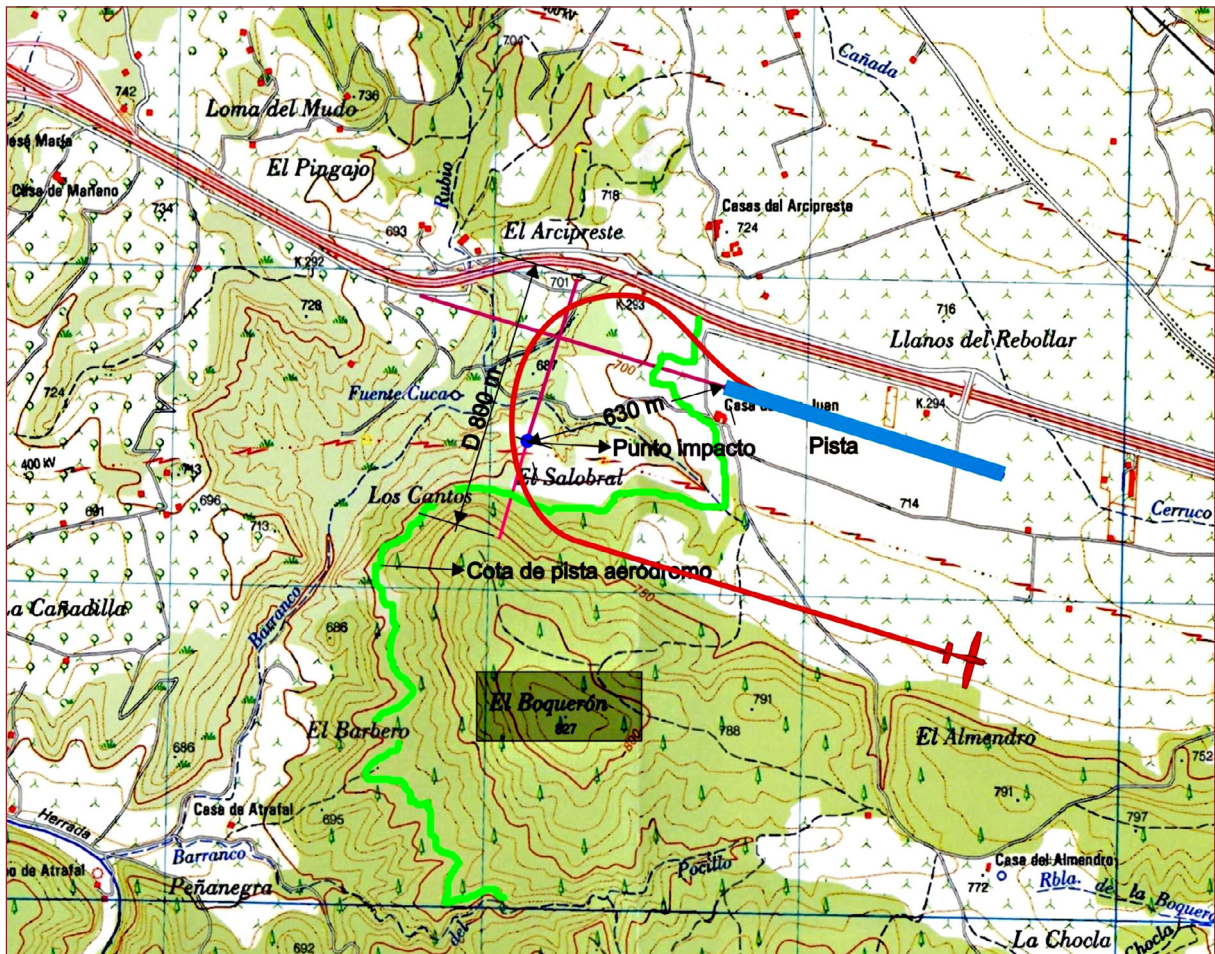
The pilot who was accompanying the accident pilot stated that he took off on runway 30 and, after opening up a bit to the right, made a 180° turn to position his aircraft on a heading to the site of the forest fire. The path he followed is shown on the following diagram.

Once the 180° turn was completed, he saw how aircraft EC-GAB became airborne following its takeoff run, but lost him from view after passing next to him. When he tried to communicate via VHF radio with the other aircraft, he did not receive a response. After spending a short time trying to establish communications unsuccessfully, he returned to the base and saw the other aircraft on the ground.

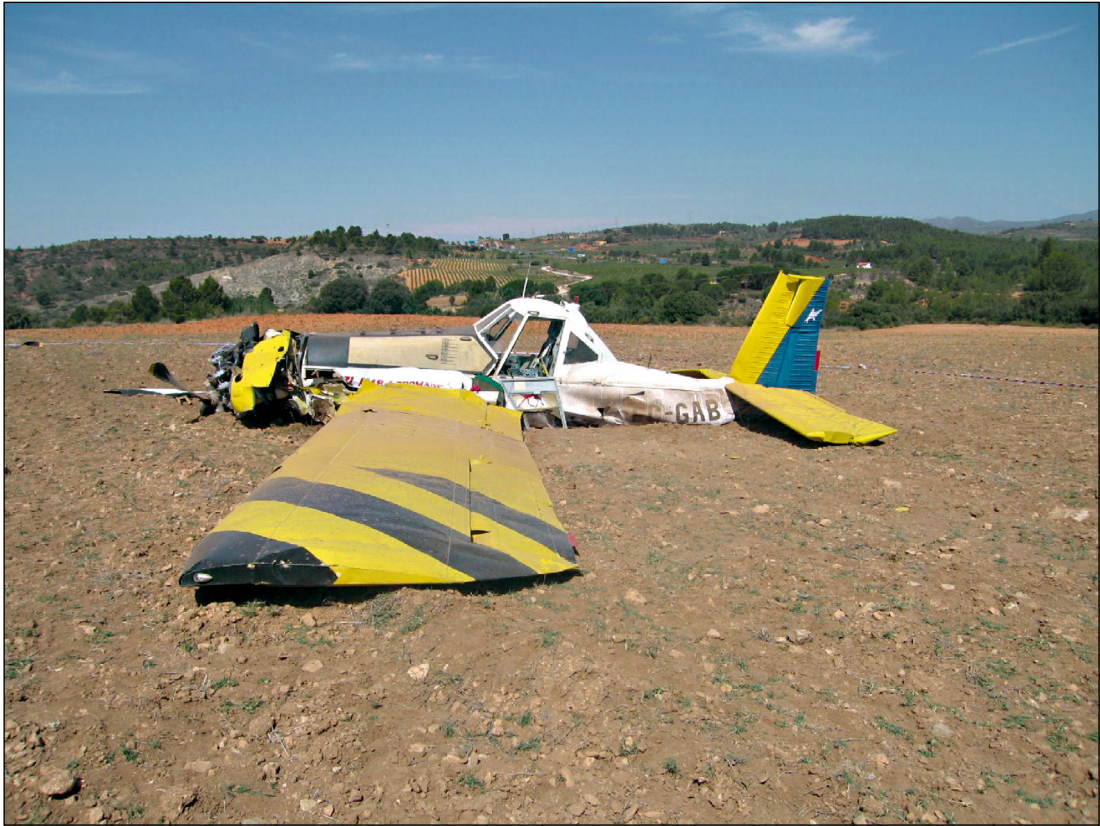
## **Aircraft wreckage**

The main wreckage was confined to a small area and came to rest in a horizontal position on a heading of 220° and slightly tilted to the left. The landing gear had collapsed, the wings were resting on the ground, maintaining their original wingspan, the horizontal stabilizer was flexed downward and the broken engine mount had allowed the engine to shift forward.

The tail skid was broken and the elevator counterweights bent.

These eyewitnesses were not able to see the direct impact with the ground, but they did see the resulting dust cloud. The aircraft was flattened against the ground after the landing gear collapsed. The wings came to rest on the ground, keeping the original wingspan. The tail section impacted the ground hard and the engine was displaced forward after detaching from its mount. The aircraft only moved two meters as it bounced and dragged along the ground. The condition of the wreckage along with the ground trail indicate that the airplane was level in the final instants of the flight and that it had a very high vertical descent rate and a very low horizontal speed. The airplane impacted the ground horizontally at a point with a lower elevation than the runway it had used just a few seconds earlier.

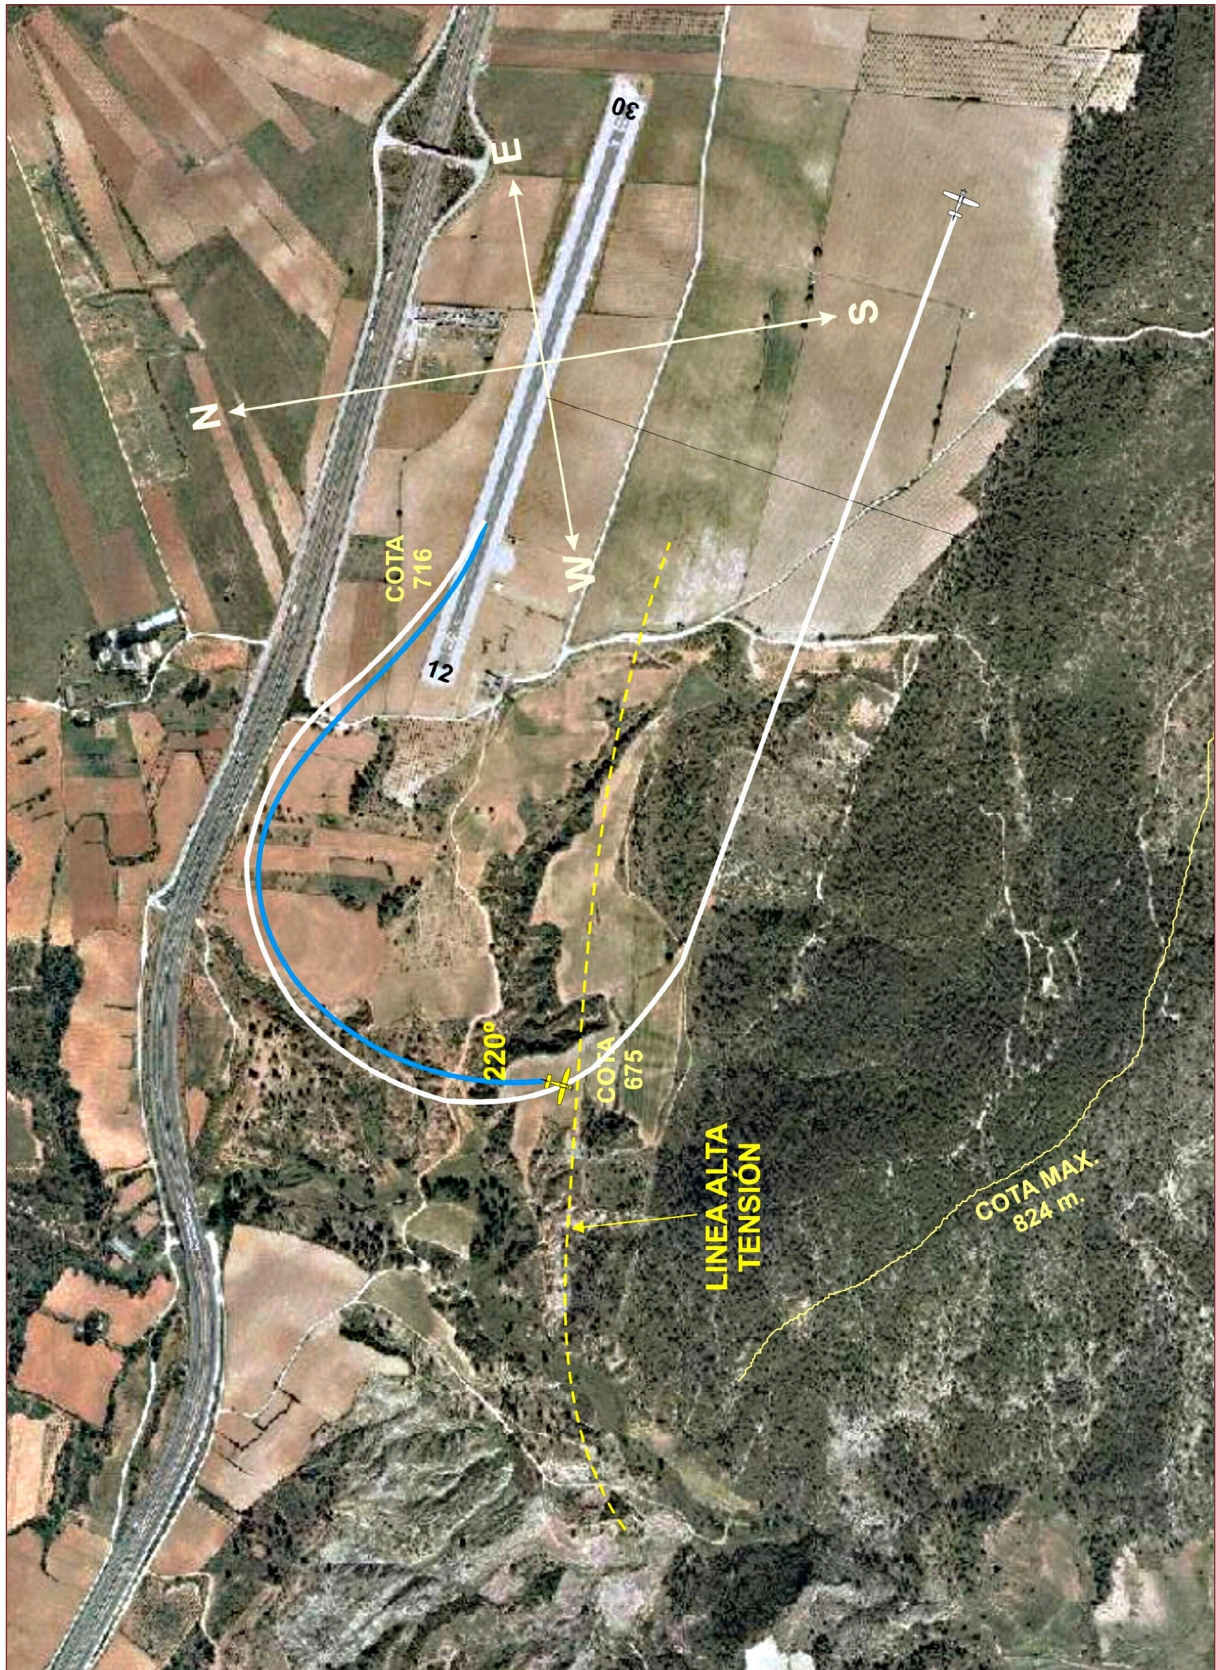
### **Aircraft trajectory**

The most likely cause of the accident was a stall during the left-turn maneuver after takeoff with a high bank angle and with insufficient speed to maintain the flight attitude.
